**DEPARTMENT OF TRANSPORTATION****DIVISION OF ENGINEERING SERVICES**

Contract #: 04-0120F4Cty: SF/ALA Rte: 80 PM: 13.2/13.9File #: 1.28**WELDING INSPECTION REPORT****Resident Engineer:** Pursell, Gary**Address:** 333 Burma Road**City:** Oakland, CA 94607**Report No:** WIR-015238**Date Inspected:** 29-Jun-2010**Project Name:** SAS Superstructure**OSM Arrival Time:** 1100**Prime Contractor:** American Bridge/Fluor Enterprises, a JV**OSM Departure Time:** 1930**Contractor:** American Bridge/Fluor Enterprises, a JV**Location:** Job Site**CWI Name:** See Below**CWI Present:** Yes No**Inspected CWI report:** Yes No N/A**Rod Oven in Use:** Yes No N/A**Electrode to specification:** Yes No N/A**Weld Procedures Followed:** Yes No N/A**Qualified Welders:** Yes No N/A**Verified Joint Fit-up:** Yes No N/A**Approved Drawings:** Yes No N/A**Approved WPS:** Yes No N/A**Delayed / Cancelled:** Yes No N/A**Bridge No:** 34-0006**Component:** Orthotropic Box Girders**Summary of Items Observed:**

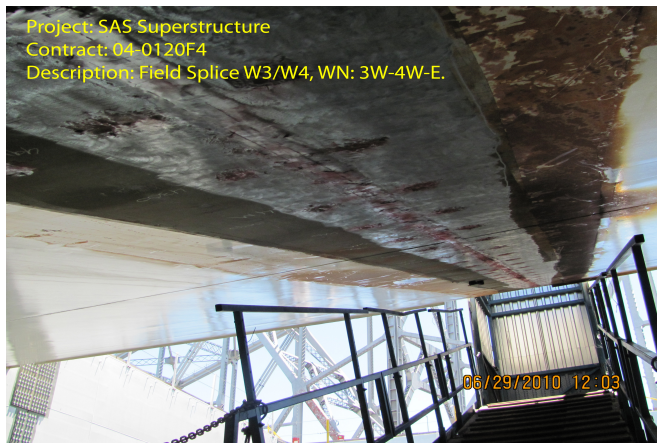
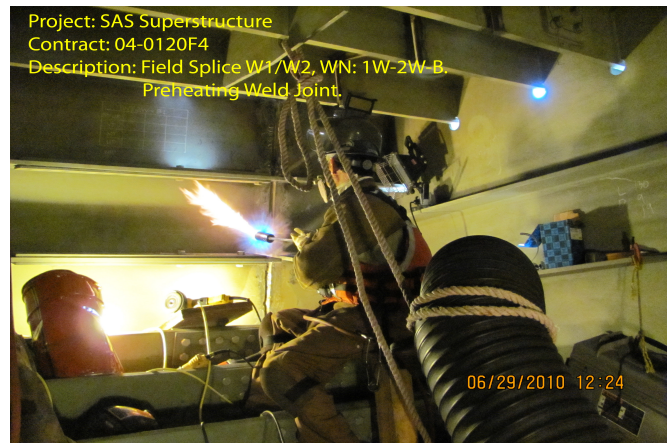
The digital photographs below illustrate the work observed during this scheduled shift.
